1. Project Name: Agat SBH
2. Date of Inspection: April 4, 2005
3. Inspection Personnel:

AGAT SMALL BOAT HARBOR, GUAM

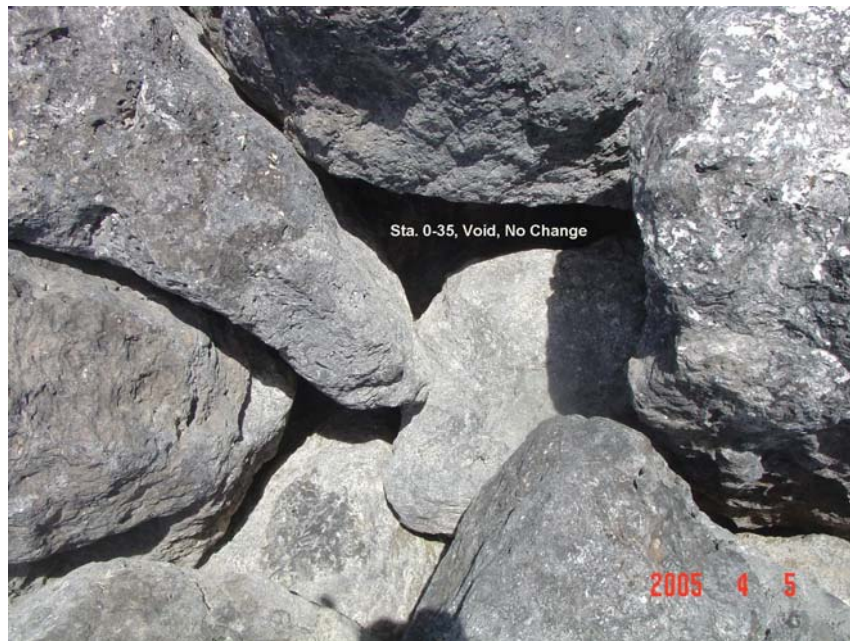
- a. Sta. 0-35, Crest/Sideslope, Void, the missing armor stones appear to be resting on the OS of the structure. No Change (NC) this year.

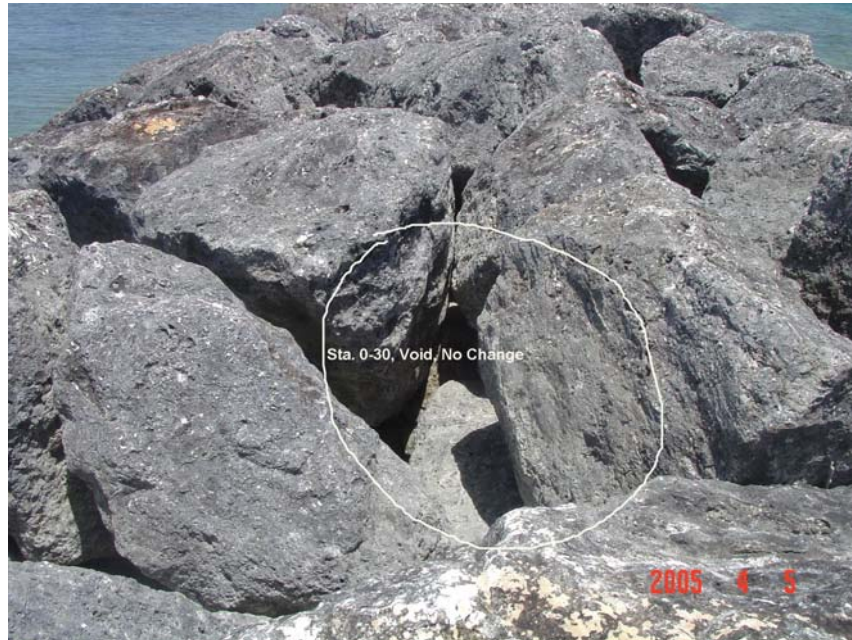
b. Sta. 0-30, Crest/Sideslope, Void, the missing armor stones appear to be resting on the OS of the structure. (FY03 photo, NC)

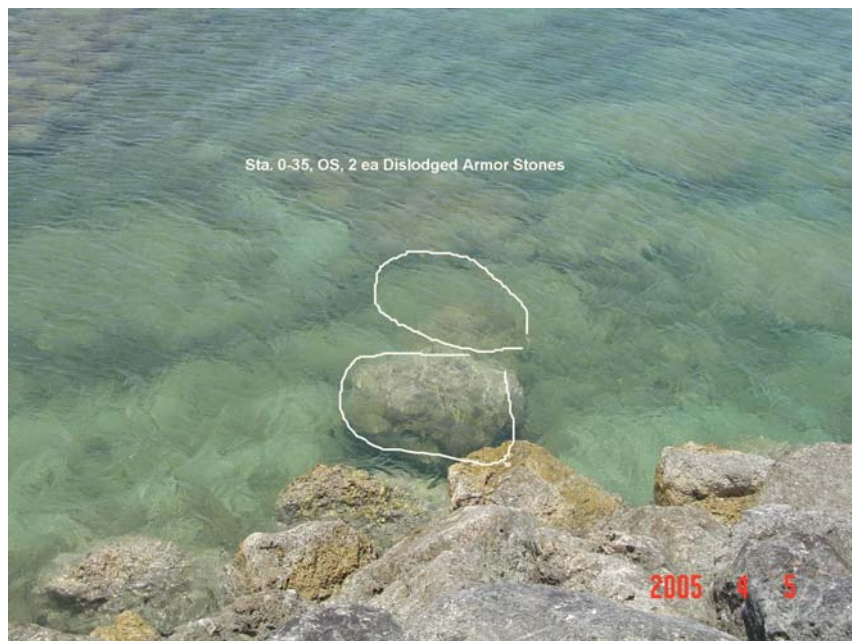
c. Sta. 0-35, 2 ea. armor stones (AS) are resting adjacent the structure. These AS may be from the above identified voids. NC this year (FY03 photo).

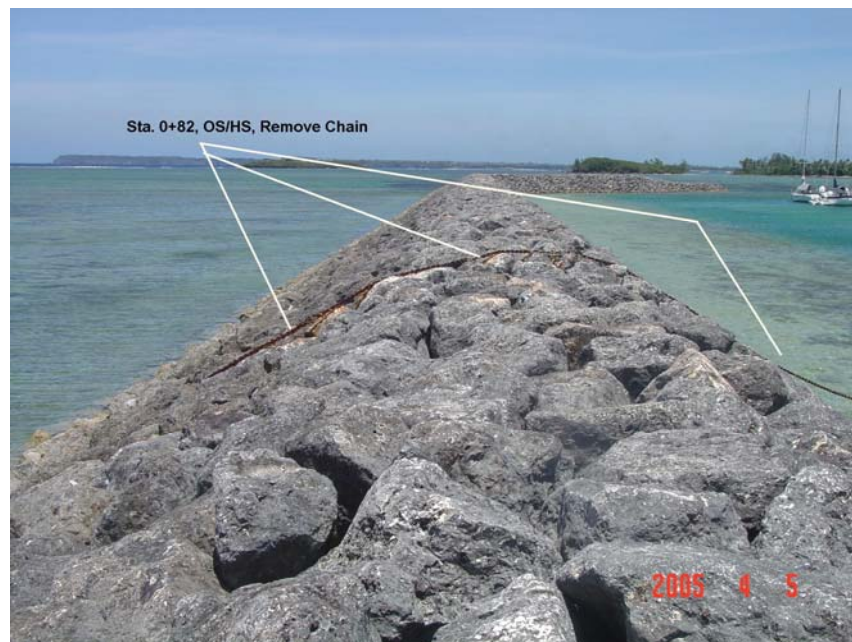
e. Sta. 0+82, OS, Remove chain.

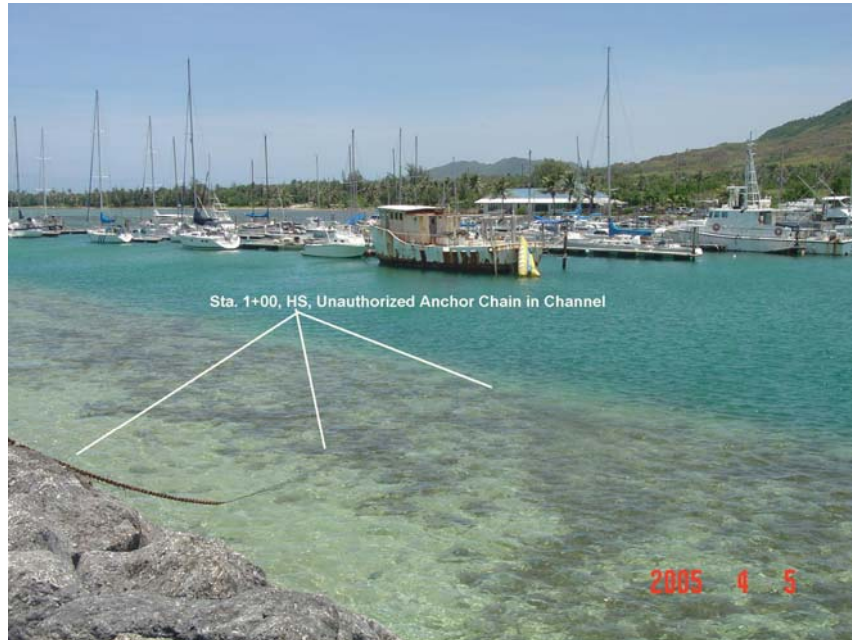
f. Sta. 1+00, HS, Un-authorized Anchor chain crossing channel.

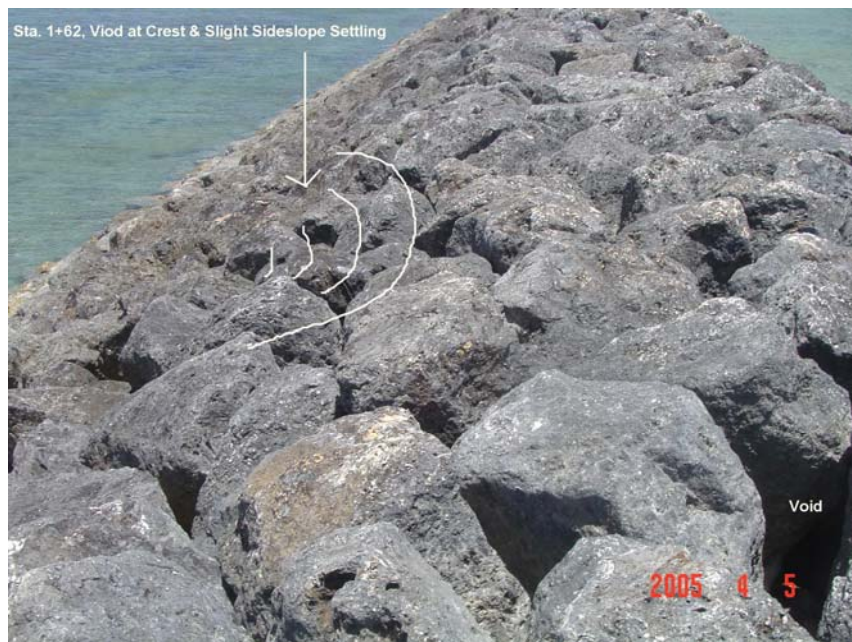
g. Sta. 1+62, OS, Monitor slight settling on the sideslope.

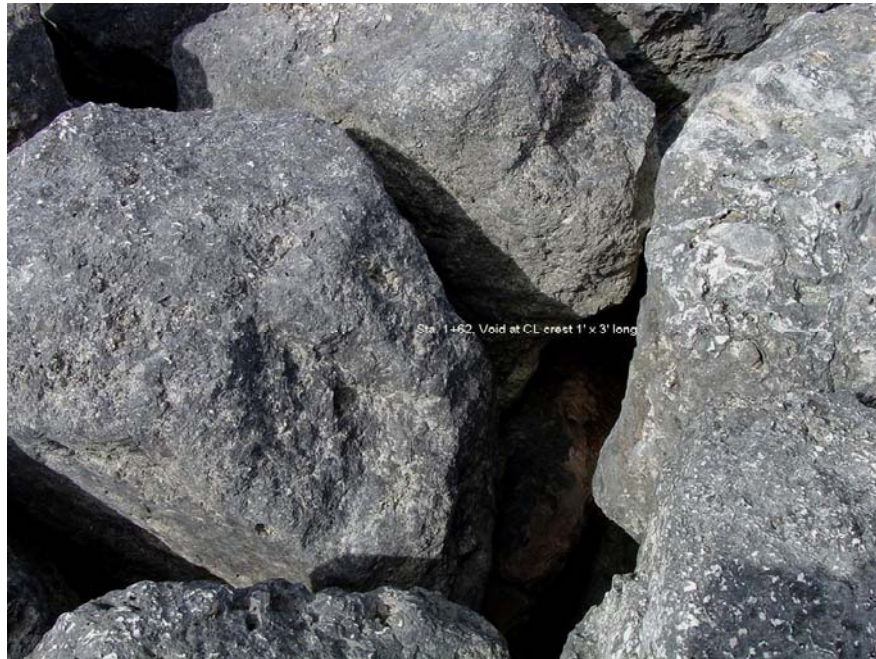
h. Sta. 1+62, CL, 1' x 3' void at crest, FY04 photo.

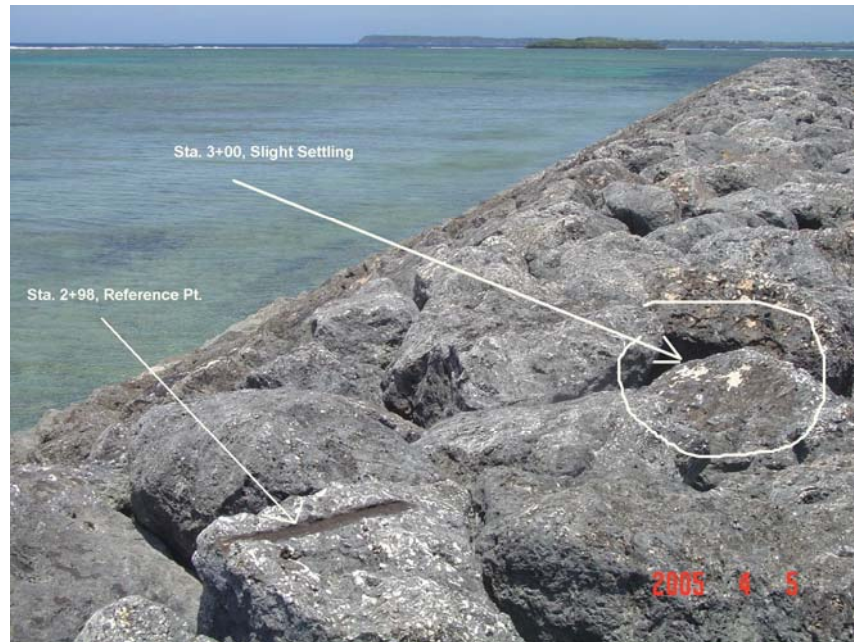
j. Sta. 2+98, Overview w/reference point, slight settling at Sta. 3+00 (new this year).

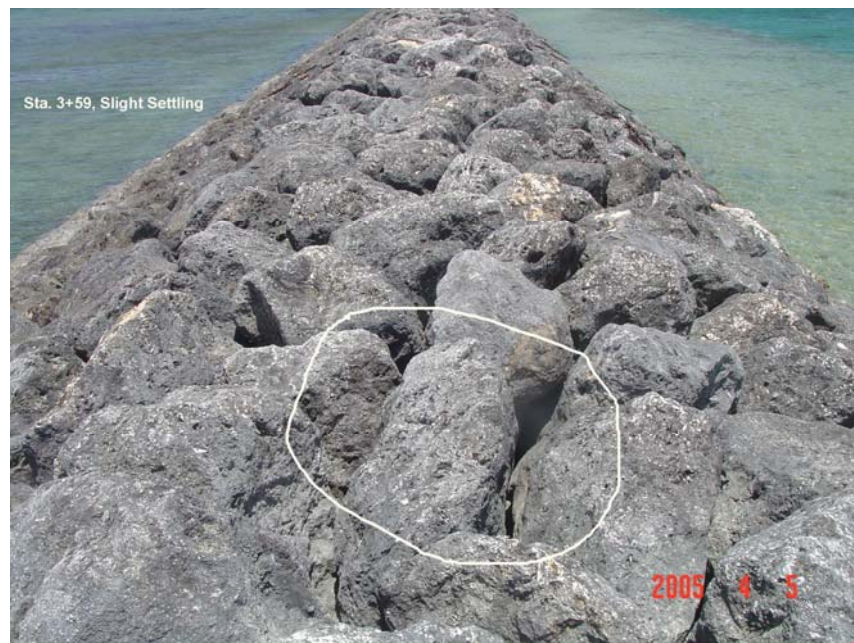
k. Sta. 3+59, CL, Monitor minor settling.

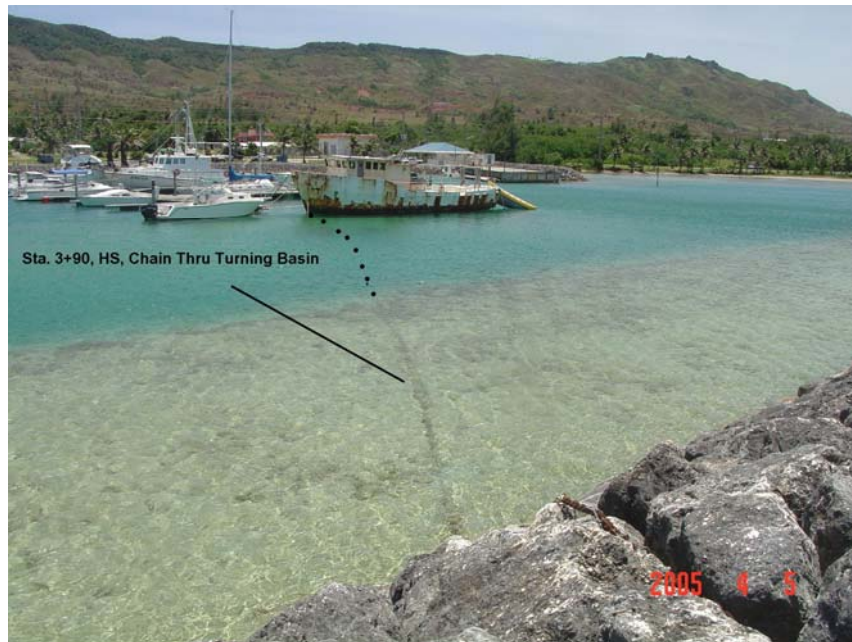
- l. Sta. 3+90, HS, Remove chains.

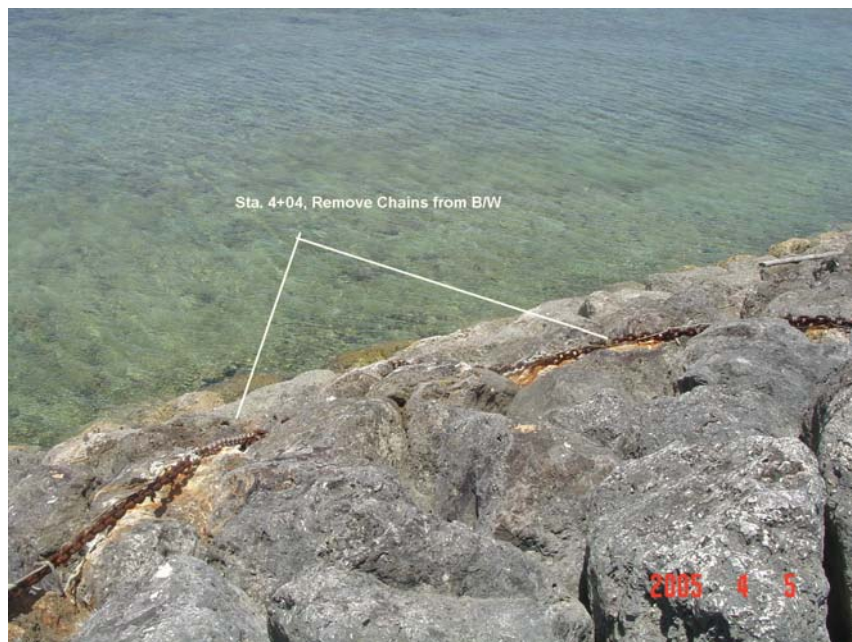
- m. Sta. 4+04, OS, Remove chains.

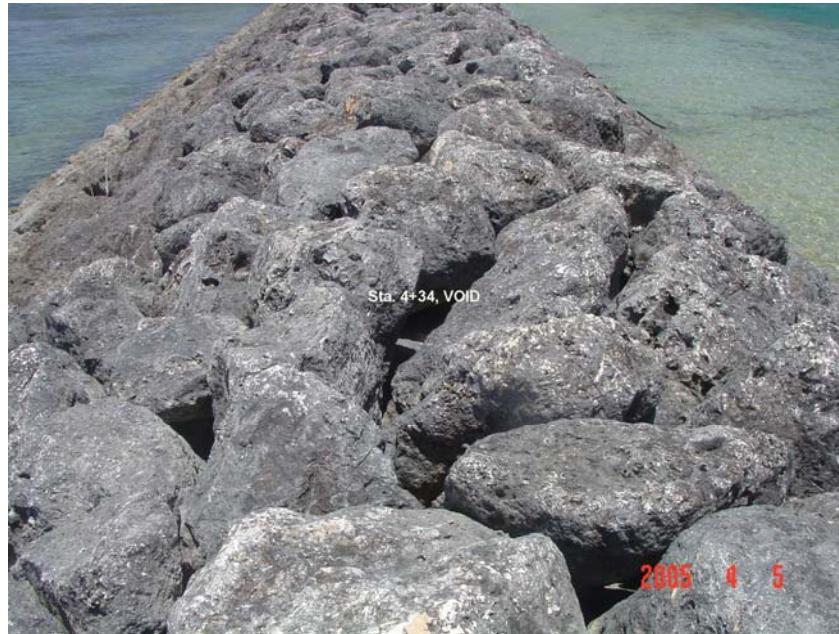
n. Sta. 4+34, CL, Void (new this year).

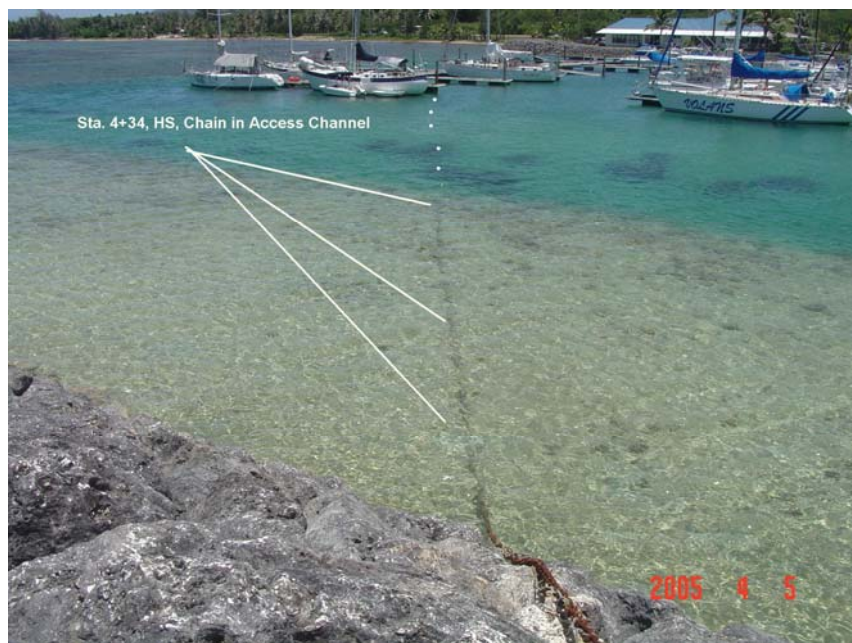
o. Sta. 4+34, HS, Remove chain in access channel
(new this year).

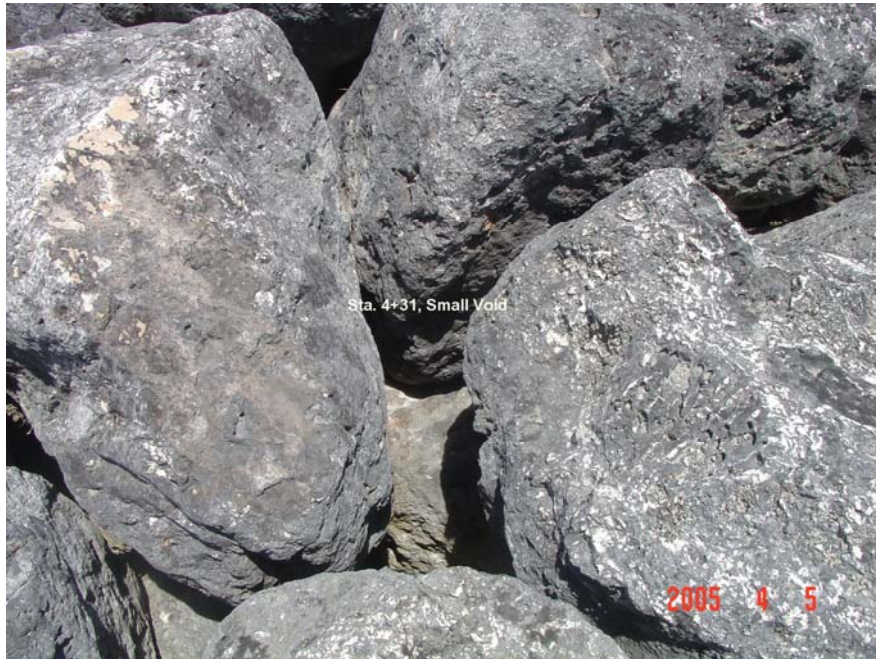
p. Sta. 4+31, Small void.

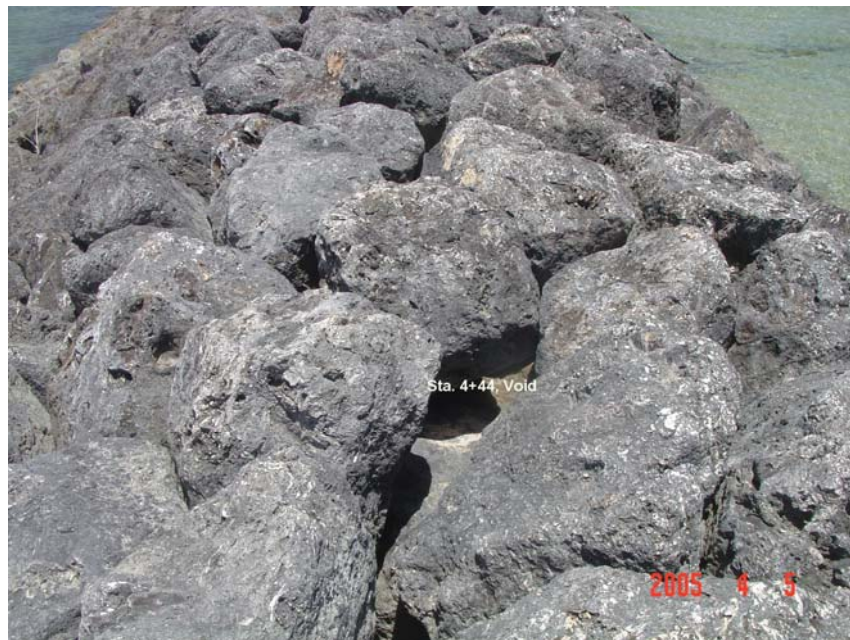
q. Sta. 4+44, CL, Monitor small void, no obvious settling.

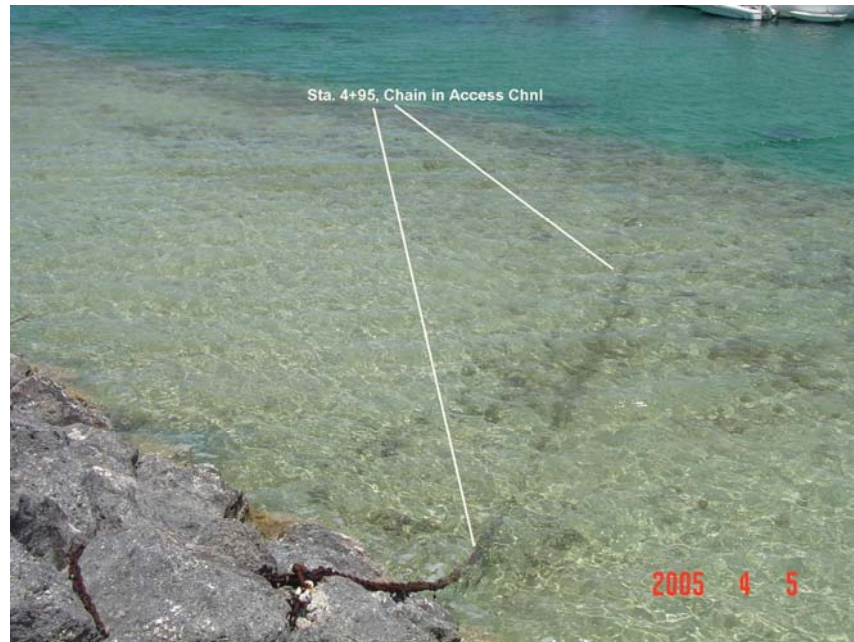
r. Sta. 4+95, HS, Remove chains.

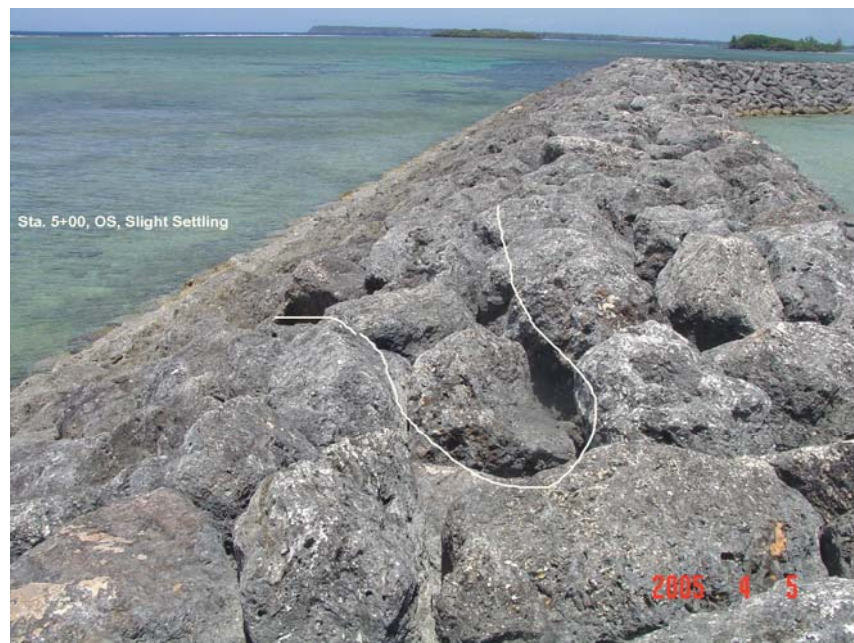
s. Sta. 5+00, OS, slight settling at crest.

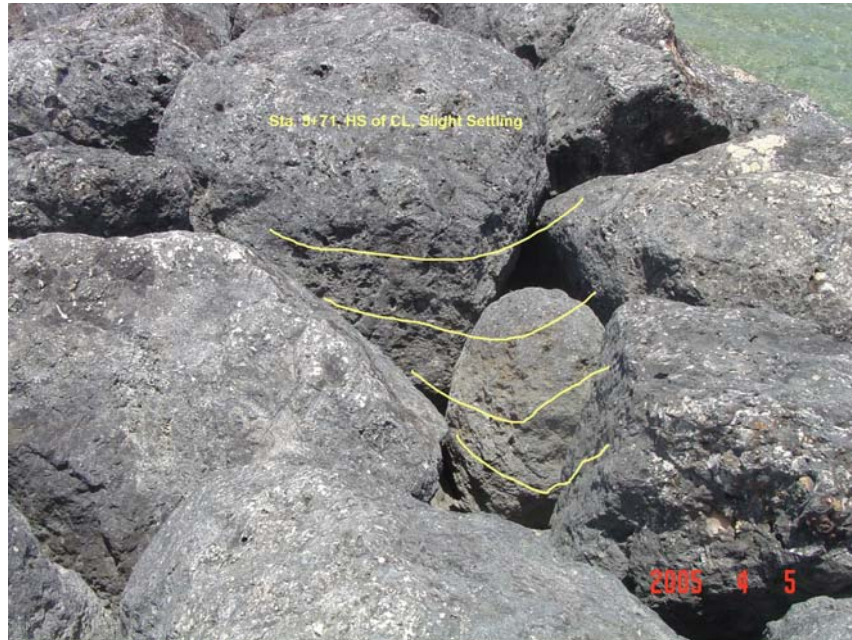
t. Sta. 5+71, HS of CL, Monitor slight settling.

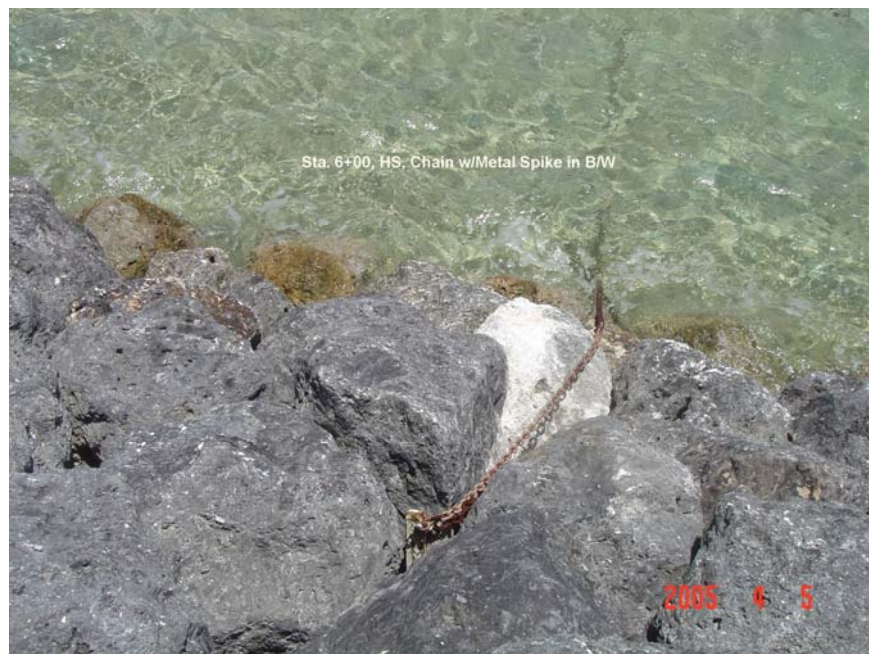
u. Sta. 6+00, HS, Chain w/metal spike.

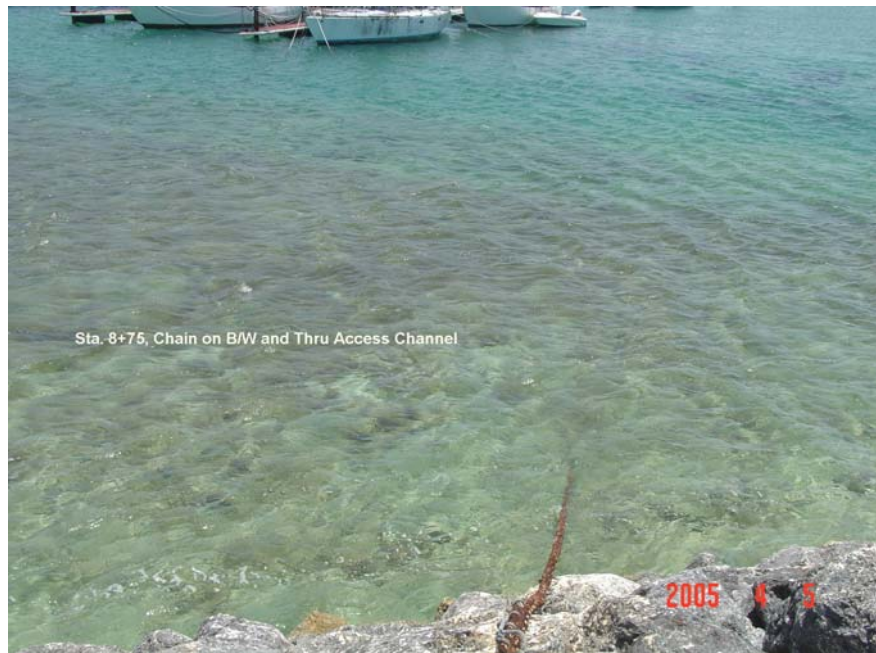
w. Sta. 8+75, HS, Remove chain in access channel.

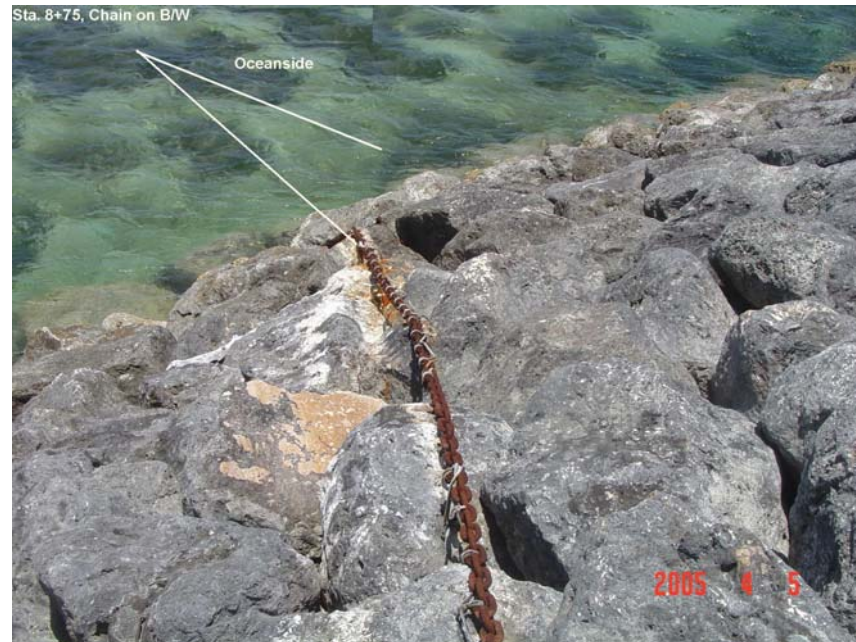
x. Sta. 8+75, OS, Remove chain.

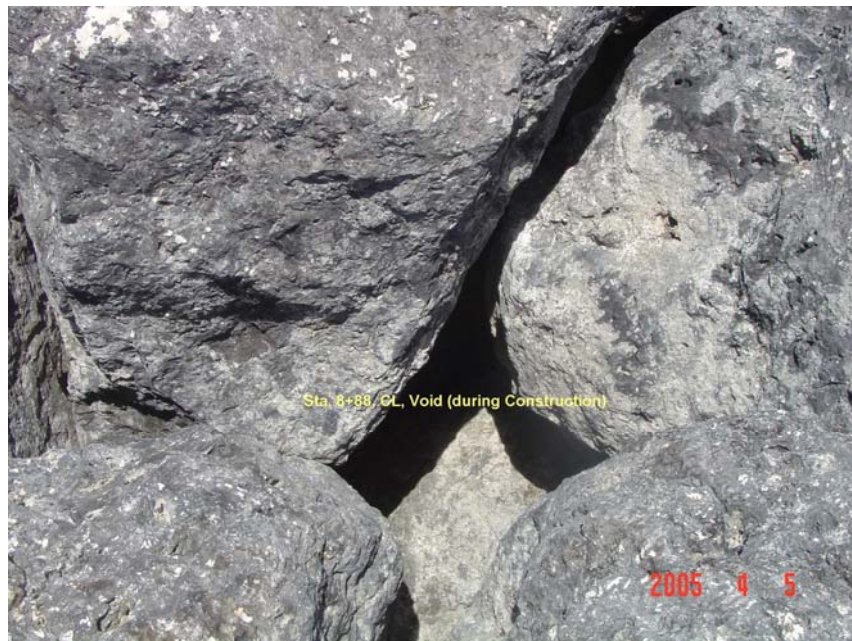
y. Sta. 8+88, CL, Monitor void area, no change this year.

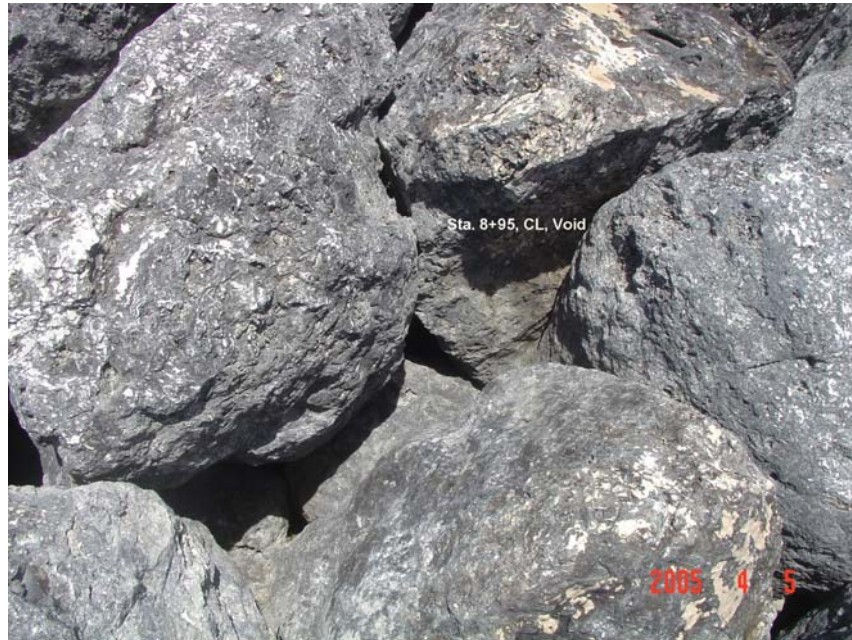
z. Sta.8+95, CL, Monitor void.

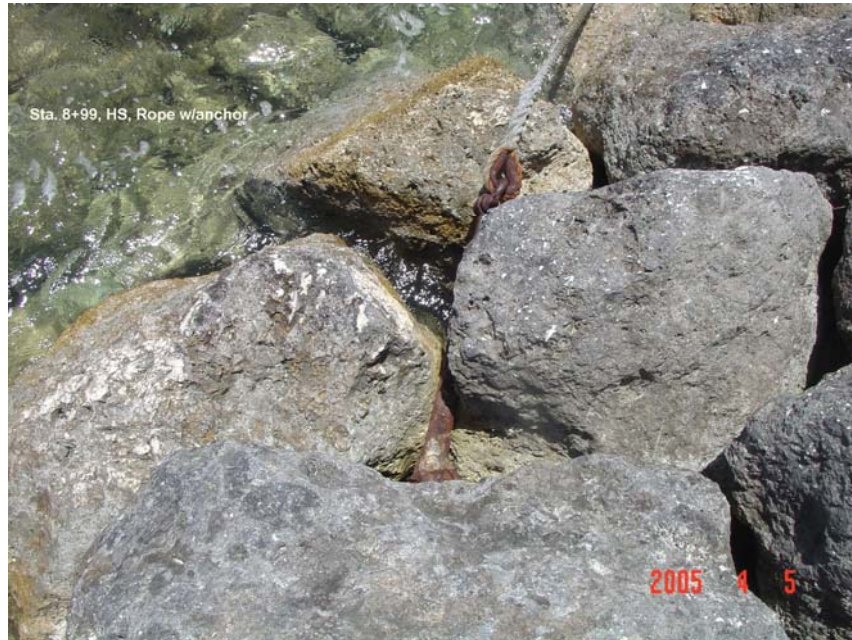
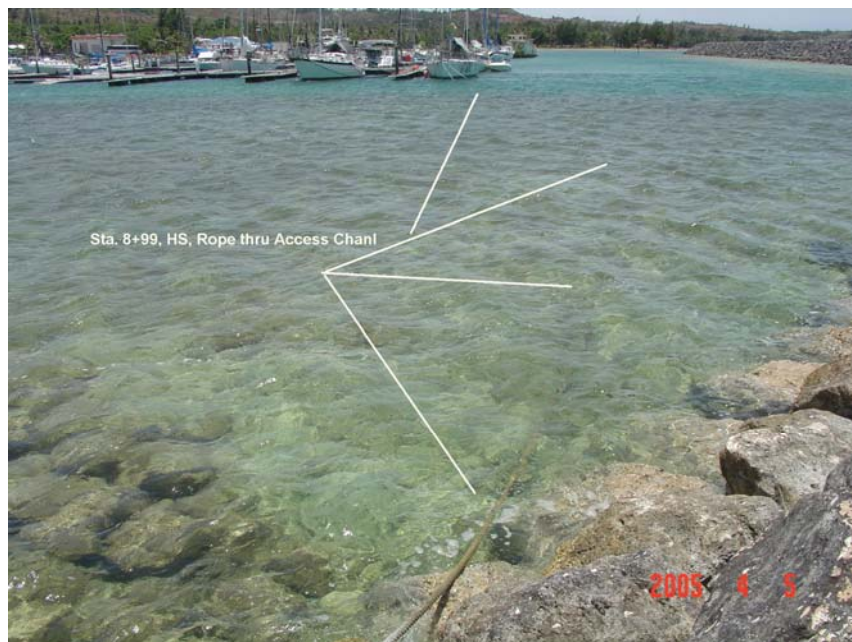
bb. Sta. 8+99, HS, and 9+16, Rope and chain.

cc. Same as Above

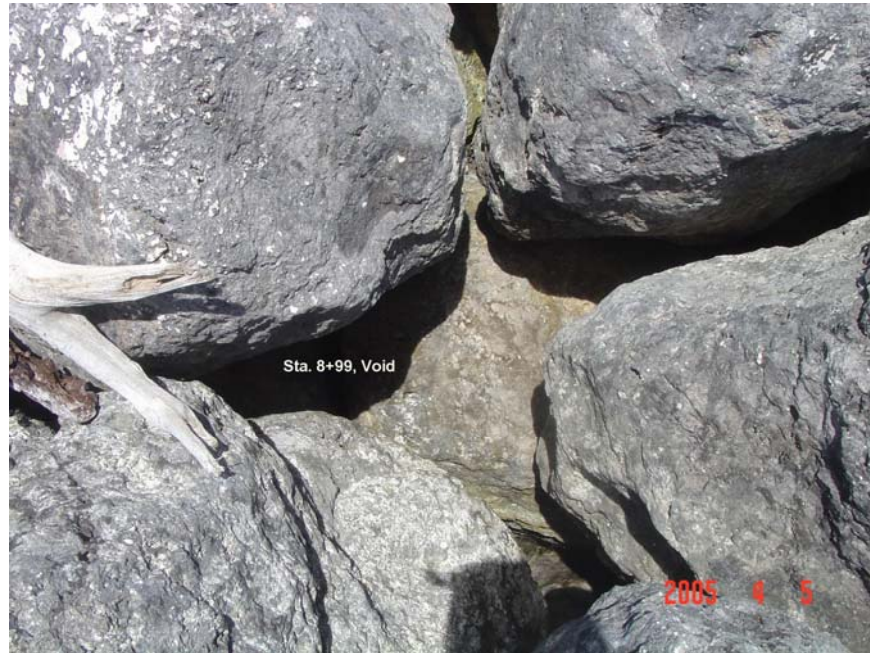
dd. Sta. 8+99, CL, Monitor void area. No Change this year.

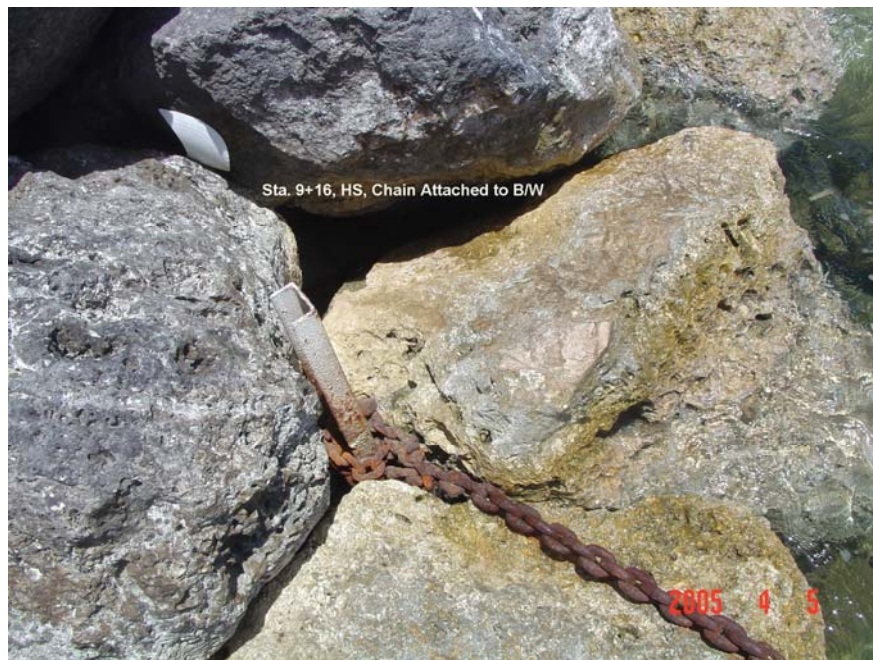
ee. Sta. 9+16, HS, Remove chain and anchor.

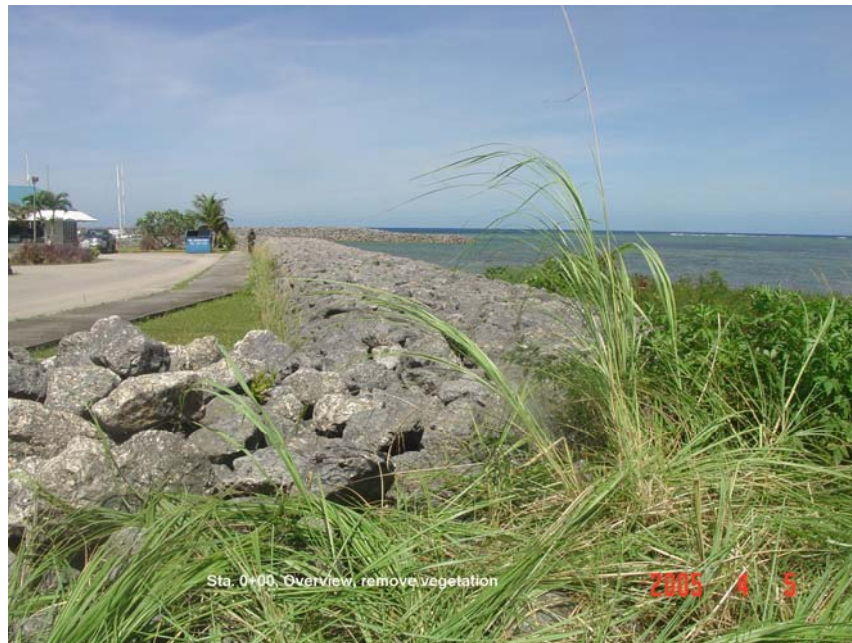
- b. Sta. 0+00, Note: 0+66, OS, Tree has been cut, still existing vegetation on crest.

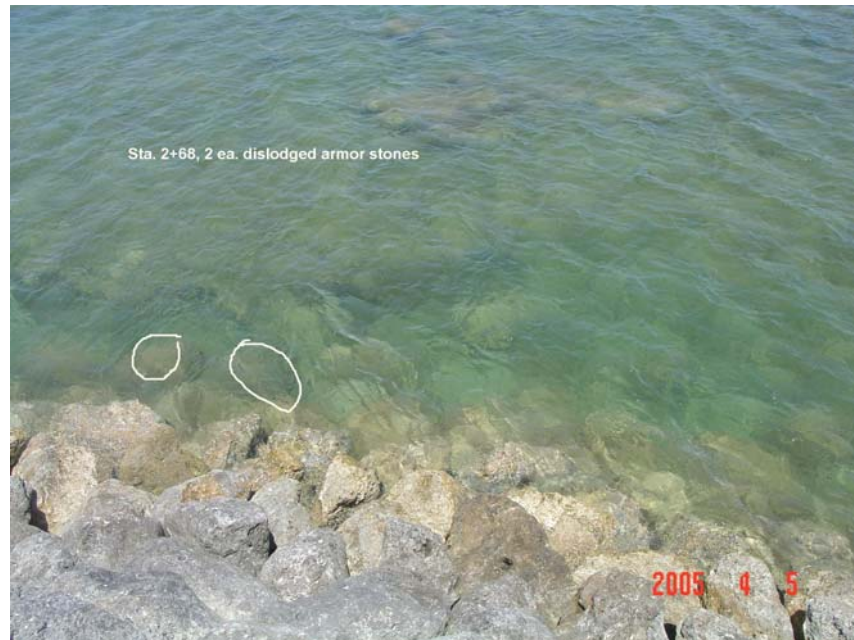
d. Sta. 2+68, OS, Monitor the toe of the structure and dislocated armor stones at this area. This area at the intersection of the berthing area dredge cut and the reef flat has "scoured" a small channel. No Change this year.

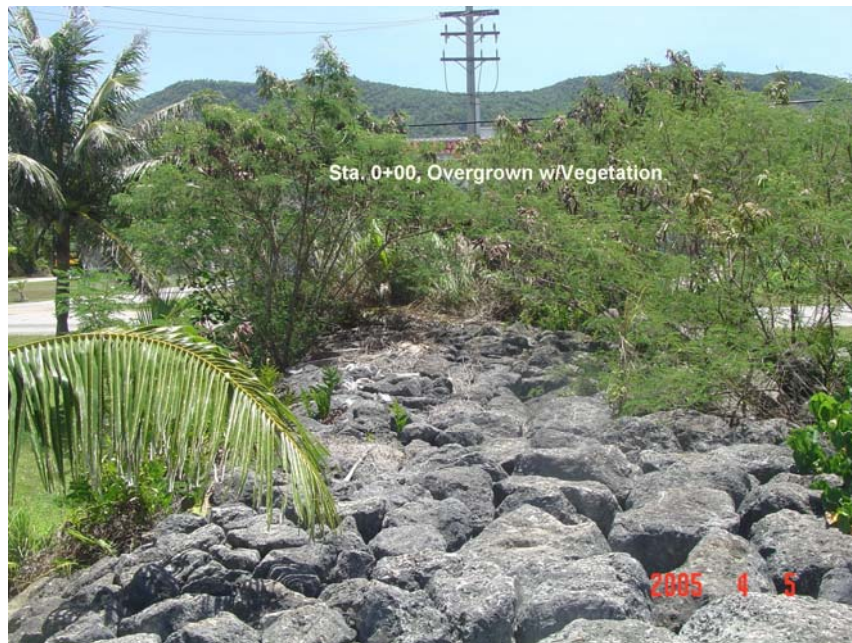
- a. Sta. 0+00 to Sta. 0+60, HS, Remove vegetation worse than last year.

Vegetation removal from the structures should be accomplished before conditions worsen. The chains that are installed by persons

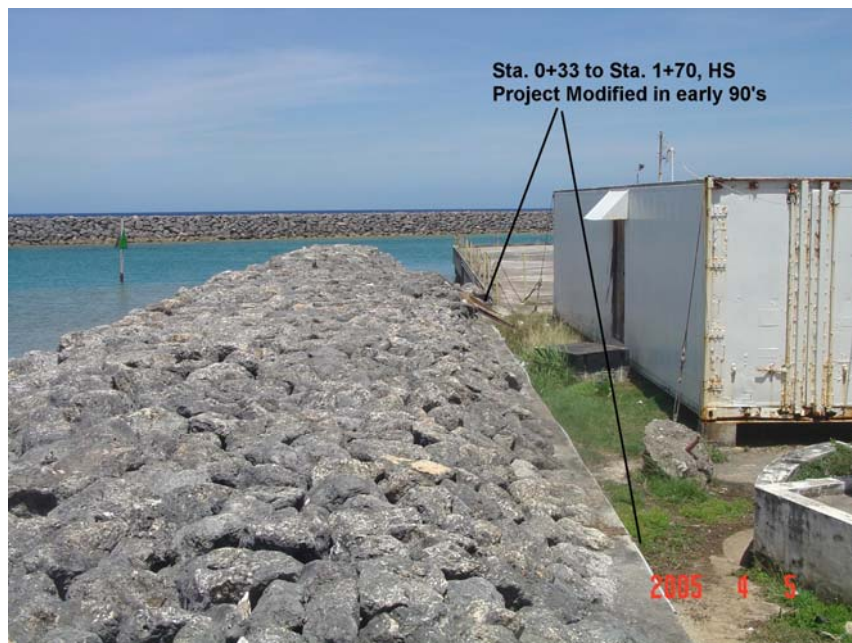
- b. Sta. 0+33 to Sta. 1+70, HS, Structure modified.

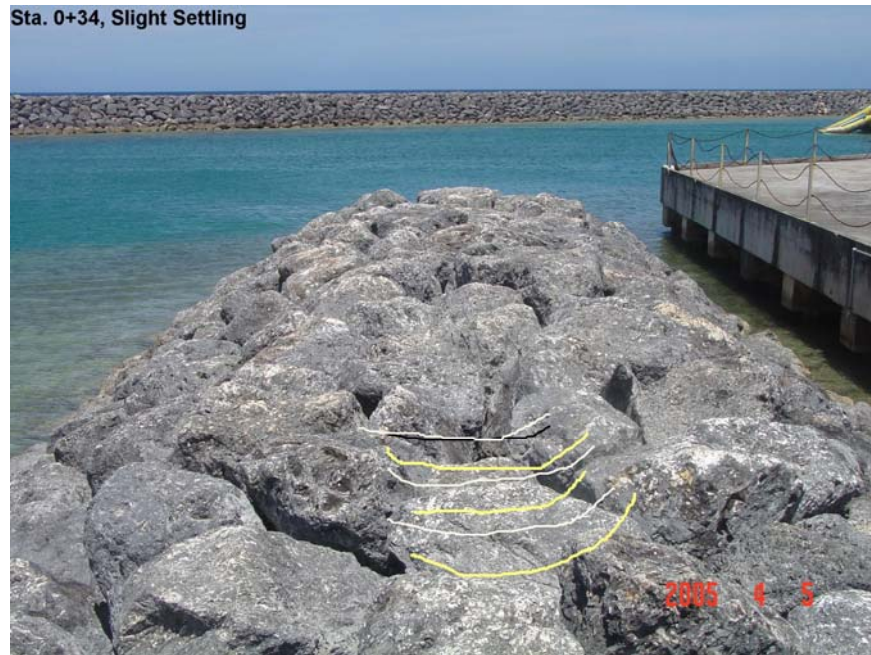
b. Sta. 0+34, CL, Monitor slight settling.
